Investigative Study Of Possible Causes Of Failure Of A Section Of Road In Jos- Plateau, North - Central Nigeria

Wazoh, H. N., Daku, S. S and Samuel, F.G.

Department of Geology, University of Jos, Nigeria

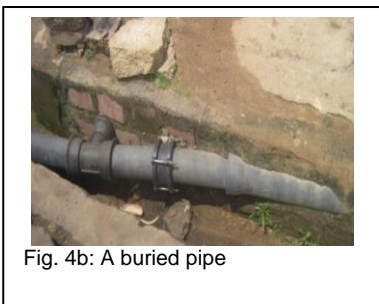
Pipes and well for municipal water supply (Fig. 4a & 4b) were left untouched during the road construction. Over time, the effects of dynamic loading of the road resulted to these pipes quickly deteriorating and leaking water into and through the pavement. Water has been observed to pour to the surface on many occasions. Pavements are not meant to hold moisture; it is a major cause of pavement deterioration [16]. Moisture tends to affect a number of pavement material properties including load bearing capacity, shrinkage and swelling. This has resulted to the deformation of the pavement under load.

Fig. 4b: A buried pipe
