Trouble Shooting Turbine Blade Damage In 55 Mw Geothermal Power Plant

Dadang Gumbira Imansyah Azis, Meilinda Nurbanasari, Agus Hermanto, Tarsisius Kristyadi

Abstract—In 2013, there was 55 MW geothermal power plant experienced a damage on 3rd-stage turbine blade due to broken tenon head caused by corrosion fatigue. Since this was a major disruption affecting business and operational performance of the plant, a quick recovery plan was required to put the plant back online while long term action plan was also prepared to improve the existing design in order to prevent the re-occurrence of the same failure mode that will be executed on the next overhaul schedule.

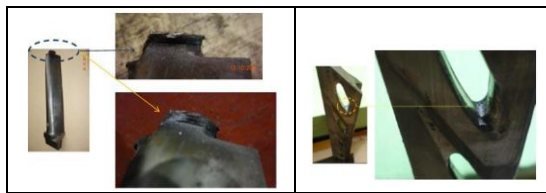
- Worn-out and broken blade tenon head detached shroud during operation
- Erosion on the blade tenon head and shroud due to steam impurities
- Fatigue crack on the blade tenon head that subject to cyclic loads

Figure 2 Wornout and broken blade tenon head and shroud

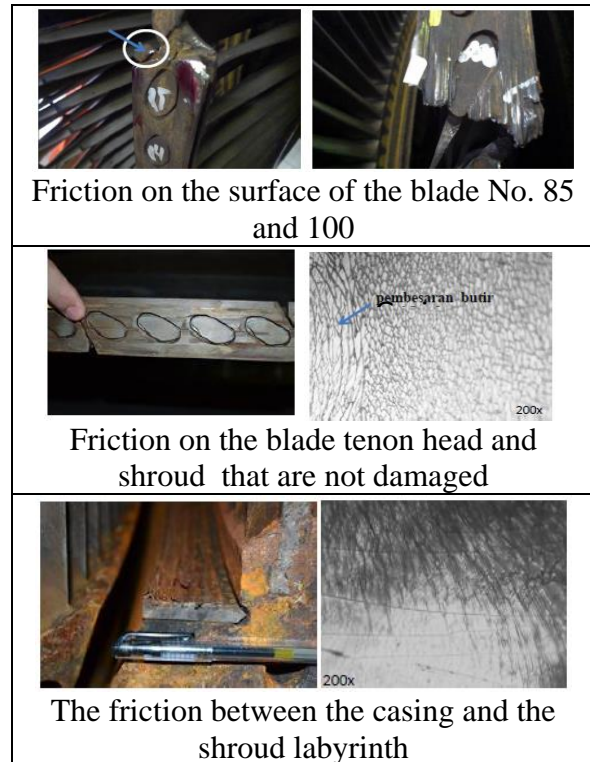
Fractography and in-situ metallography analysis on the shroud fracture surface reveal enlarged grain diameter (Figure 3) adjacent to the shroud that indicates the area has experienced overheating as a result of severe friction between the shroud and the labyrinth. The presence of damage on the labyrinth of stage 3, highly broken-deformed shroud due to high temperature and frictions on the surface of the shroud and blade tenon head that did not fail justify that analysis result.

Figure3 Friction on blade tenon head, shroud and labyrinth

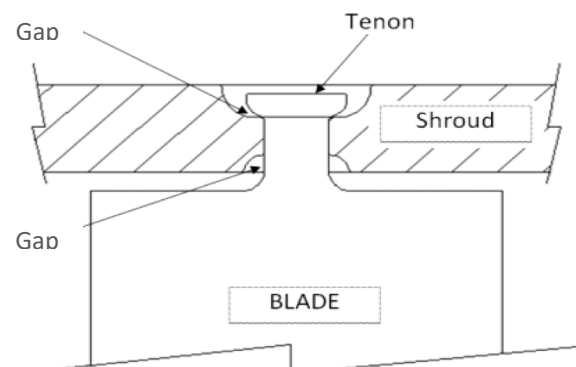
In the existing 3rd-stage turbine blade design (Figure 4), there is discontinuity volume between blade tenon head and shroud that is fastened with the process of hot irreversible plastic deformation (rivetting) during the initial blade assembly process. This design create gap between the shroud and tenonhead and become local stress concentrations which prone to corrosion attack that is justify by fractography analysis result that showed the occurrence of crack and corrosion (Figure5).

Figure4 Existing 3rd stage turbine bladedesign

There are several designs of the shroud which utilize rivet or integral shroud. Rivet with the square root section of the existing turbine design only suitable for ultra-light service. Punching process during rivetting and some flaw on the rivetting result create discontinuity volume between the blade and the shroud and generate stress concentration on the plate and blade tenon head which initiate the crack. In the design of integral shroud, shroud plate is an integral part of a turbine blade that is used for medium-heavy service (Nauman, 1982).

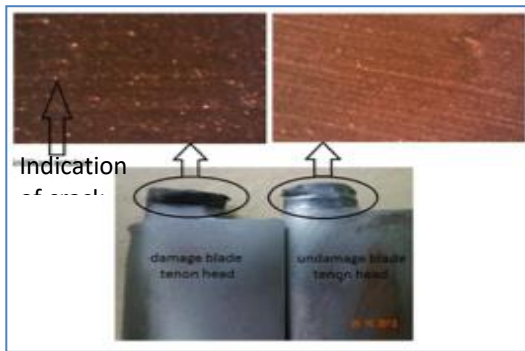
Figure 5 Crack on blade tenon head

As in the previous section, the existing turbine design create gap between the shroud and tenonhead and become local stress concentration and with the presence of water vapor, H₂S and other chemicals cause corrosion on the blade tenon head that initiate the crack on the blade tenon head. Fractography analysis

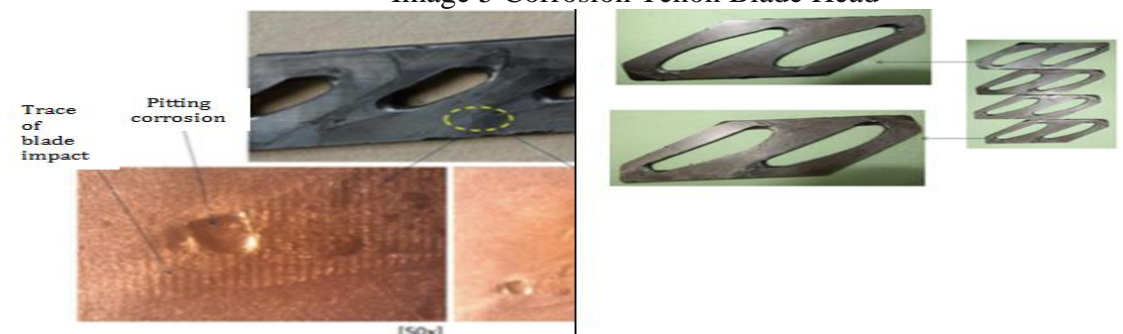
and metallographic results showed corrosion on the surface of the shroud and blade tenon head. In addition to that, pitting corrosion and corrosion deposits are found on the bottom surface of the shroud and the joint area (figure 5 and 6) that have contact with blade tenon head is an evidence of corrosion attack that area. This corrosion attack and cyclic load lead to dimensional changes in the blade tenon that enlarge the gap and the relative movement that cause abnormal vibration. The combination of corrosion, worn-out blade tenon head, the influence of the bending load (unsteady steam forces, rotor torsion, radial vibration, axial vibration), the plant start-up and shut down process and steam conditions (pressure and temperature) cause the blade tenon head failure due to corrosion fatigue (Mc.Closkey, 1999). The presence of impurity in the vapor can accelerate corrosion rate and fatigue of blade tenon. The worn-out blade tenon head and the shroud is then broken that cause the shroud to detach from the turbine.

Figure 6 corrosion pitting on the surface of the bottom shroud
