# Improving The Air Tightness Of An Early 20th Century House

Rosanne Walker, Sara Pavía  
Dept of Civil Engineering  
Trinity College  
Dublin 2, Ireland  
[walkerro@tcd.ie](mailto:walkerro@tcd.ie) [pavias@tcd.ie](mailto:pavias@tcd.ie)

This paper investigates several draught reduction measures suitable for a traditional house. The success of the interventions was investigated by measuring air permeability rates (air blower), thermal imaging and monitoring room temperature.

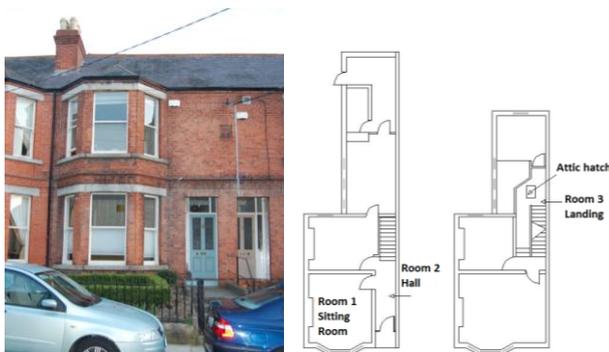
Fig. 1. Photograph of house and floor plan. Front elevation is north facing.

Testing was undertaken on an Edwardian terrace house built c.1910 located in Dublin, Ireland. The floor plans as shown in fig 1 and are typical of the typology. The walls of the house are constructed of solid red bricks with internal lime plaster in the traditional manner. Draught reduction measures were investigated in 3 rooms. Room 1- sitting room, room 2 – hall and room 3- landing.

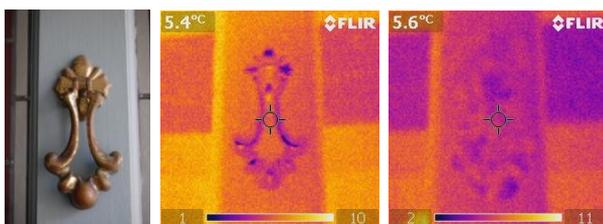
Fig. 2. Brass door knocker and thermal image of knocker uncovered (centre) and covered with masking tape (rhs) with smaller emissivity difference between knocker and door

Thermal imaging is qualitative and allows an approximation of surface temperatures of an object. The image depicts infrared radiation not the true temperature of the pictured object. The emissivity coefficient ( $\epsilon$ ) was fixed at 0.93, to accommodate the widest range of building materials. Differences in emissivity of materials can influence the colours of the thermal images. For this reason, the emissivity of materials in the images was kept as close as possible. The ironmongery (knocker, letterbox and keyhole) and door have varying emissivity therefore the ironmongery was covered in masking tape so that emissivity of the ironmongery was closer to that of the painted timber door as shown in Fig 2. The timber floor and underlay also have varying emissivity and the underlay was therefore placed beneath the floor surface so that only the floor surface is captured in the thermal image.

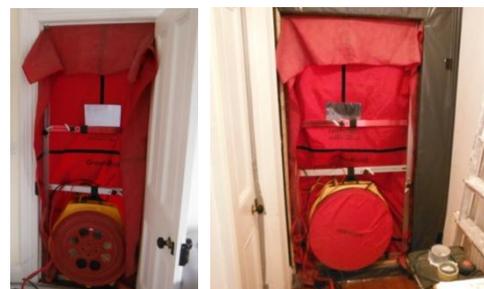
Fig. 3. Image of air blower fan inserted in internal door opening (room 1) and in frame at bottom of stairs (room 2).

A Retrotec 2000 fan and DM2 Mark II gauge micromanometer were used to carry out the testing. Data was manually logged and analysed using Fantestic software. A multipoint test (pressurisation and depressurisation) was undertaken, the pressure inside the room was increased to 70Pa and reduced gradually at c.10Pa intervals by altering the fan speed. The indoor air temperature varied between 12.1-14.8 °C and the external temperature 2.7-7.7 °C. The wind speed was >1 m/s and barometric pressure varied between 100.9-101.6kPa. The fan was installed in the internal door opening for room 1 (sitting room), in a frame at the bottom of the stairs for room 2 (hall) and the front door for room 3 (landing)

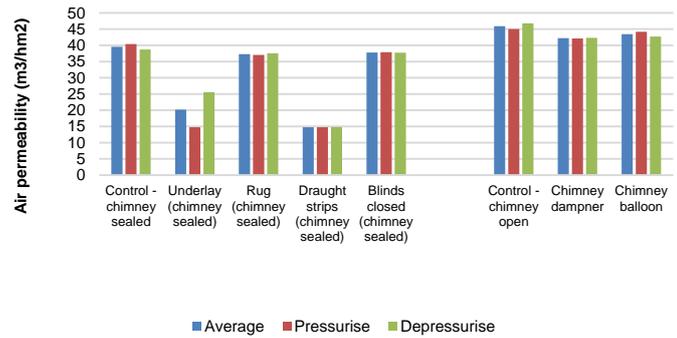
Fig. 4. Air permeability (m<sup>3</sup>/hrm<sup>2</sup>) of room 1 (originally) and room 1 following various draught interventions. Description of draught reduction measures in Table 1. The chimney was sealed (left bar of graph) with plastic sheeting taped to the fireplace to stop all draughts through the flue.

The air permeability and room temperature results for room 1 are shown in figs 4 and 5 and table 4. The air permeability of the room (with chimney sealed) of 39.55 m<sup>3</sup>/hm<sup>2</sup> is very high compared to typical dwellings. The air flow exponent (n) of the air blower tests ranged between 0.53 and 0.57 with an average of 0.55 (excluding underlay test, n=0.73). This is a low figure that indicates a turbulent flow regime through large openings and is suggestive of a leaky building.

The air blower results comparing the sealed (with plastic sheeting) and unsealed chimney indicate that the chimney is responsible for air permeability of 6.3 m<sup>3</sup>/hrm<sup>2</sup> @50Pa (45.9-39.6 m<sup>3</sup>/hrm<sup>2</sup>) which accounts for 13.8% of the air flow from the room. The air flow

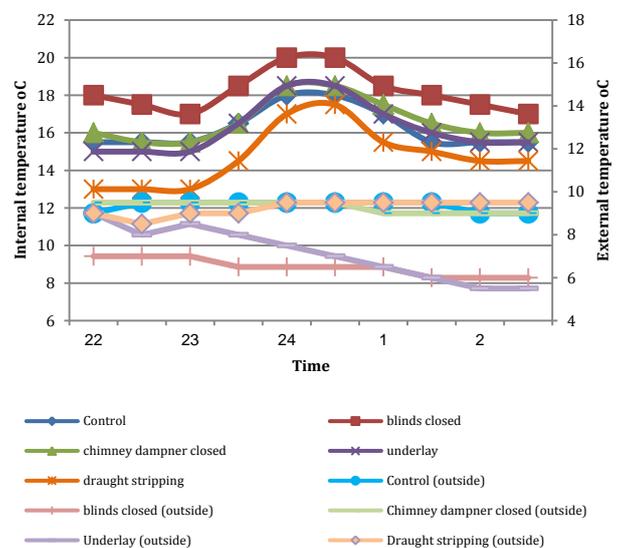
Fig. 5. Internal and external temperature logging for room 1 following various draught interventions. Control – no intervention and chimney open. Description of draught reduction measures in Table 1.

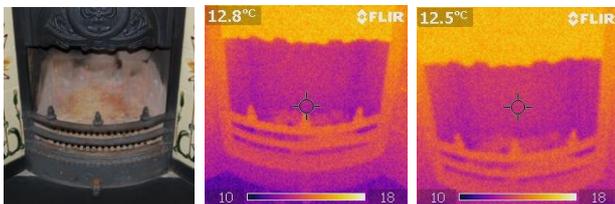
Fig. 6. Fireplace and thermal image of the fireplace with the chimney damper open (centre) and closed (right) showing no difference in temperature in the localised area surrounding the fireplace.

Thermal imaging and room temperature monitoring was only undertaken on the chimney damper which proved most successful at reducing draughts according to the air blower testing. The room temperature monitoring showed that closing the chimney damper during a heating cycle allowed the room to increase in temperature by 0.5°C. The thermal images (fig 6.) showed no difference in the temperature surrounding the fireplace whether the damper is open or closed. This suggests that the cooling effect can be attributed to warm air escaping by the chimney and being replaced by cool air drawn in through other openings in the room such as the windows and floor rather than to a localised colder area near the fireplace.

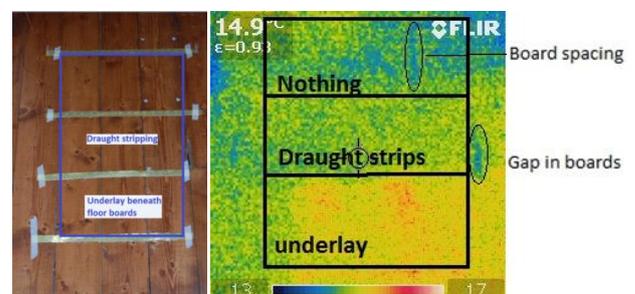
Fig. 7. Left: Photograph of section of floor tested subdivided into three sections: top – unchanged; middle – draught stripping between floor boards and lower section – underlay beneath floor boards. Right: thermal image of the floor section showing the varying thermal performance.

The thermal image in figure 7 shows a section of timber floor subdivided into three sections using metallic tape. The floor boards remain unchanged in the upper section of the photograph, draught strips are inserted between the boards in the middle section and underlay positioned beneath the floor in the lower section as marked on figure 7. The underlay has a different emissivity coefficient than the floor boards and therefore thermal images could not accurately compare the performance of the two materials. However, by placing the underlay beneath the floor boards, the image only captures the floor surface and therefore a temperature comparison can be made between the floor with and without the underlay. The unchanged floor boards show blue areas indicating cold air coming from beneath the floor through the gap between the floor boards. It is likely that this cold air escaping from between the boards is slightly cooling the surface of the boards resulting in their lower temperature compared to the boards with draught stripping (slightly warmer - less blue sections). The thermal images show that the section of floor boards with the underlay beneath is warmer (yellow-red, approximately 15-16°C) than the section of floorboards without it (blue-green approximately 13.5-14°C) indicating that the underlay is reducing the heat transfer through the floor.

Considering both the air blower results and thermal images, it is evident that the draught strips largely reduce heat loss through minimising air leakage between the boards and slightly increases the surface temperature of the floor. The underlay both reduces the thermal conductivity of the floor and also reduces air movement between the boards.

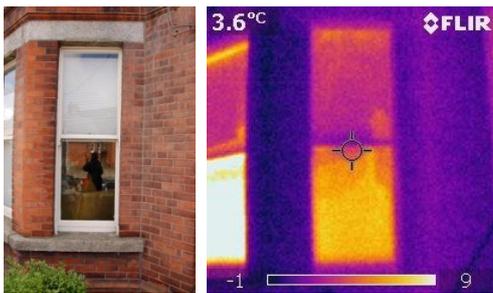
Fig. 8. Sash window and thermal image of exterior of window with reduced heat loss through the upper sash

More significantly, the blind reduces heat transfer through the window as shown in figure 8. Thermal images of the sash window were taken from the exterior with the blind covering the top sash. The thermal image shows an approximate surface glass temperature of 1 °C and 6 °C for the upper sash and lower sash respectively. These temperatures show a temperature differential rather than actual temperatures as glass is a poor emitter of infrared energy and measured temperature are likely below actual temperatures. The upper sash is cooler as the blind prevents warm air from warming the glass and leading to heat loss. This image clearly indicates the positive effect of the blinds on reducing heat transfer through the window. This agrees with Baker (2008) who measured a reduction in heat loss through the window of 36% in a single glazed sash with and without a thermal honeycomb blind [19].

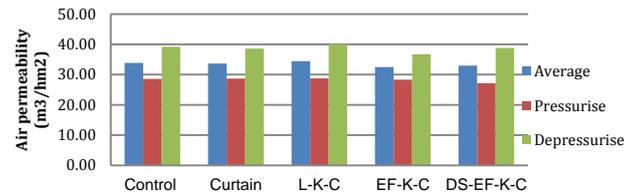
Fig. 9. Air permeability (m<sup>3</sup>/hm<sup>2</sup>) of room 2 (unchanged) and of the room following various draught interventions. Control – no intervention, description of abbreviation of retrofit measures in table 1.

The air permeability and room temperature results for room 2 are shown in figures 9 and 10 and table 5. External doors are a significant source of air leakage [21]. In the air blower tests, it was evidenced that the pressurisation air permeability was lower than the depressurisation air permeability. Stephens (1998) observed that differences in pressurisation and depressurisation tests can vary by up to 20% as aerodynamic effects differ depending on the direction of air flow [15]. In this instance and considering the similarity of the pressurisation results (varying by only 5% from the average) and depressurisation results (varying only 4% from the average), it is likely that door components are sealing tightly when the interior is pressurised (reducing air permeability) but releasing when the pressure is reversed.

The door curtain did not reduce draughts through the door (figure 9- result within the estimated 5% measurement error) but allowed the hallway to achieve a slightly higher temperature (0.5 °C increase) during the heating cycle. The thermal images suggest that the curtain reduces heat loss. As shown in fig 11, the door with no intervention (centre) is slightly lighter in shading than the door with curtains. This indicates that it is slightly warmer and consequently, more heat is transferring through it. The greater heat loss through the door with no curtain can be seen when comparing features of the two images: at the no intervention door in the centre, white predominates at the overlight while the letter box is yellow rather than purple and the door

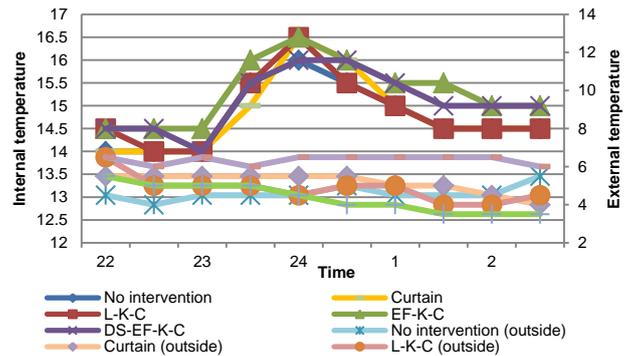
Fig. 10. Internal and external temperature logging for room 2 (unchanged) and of the room following various draught interventions

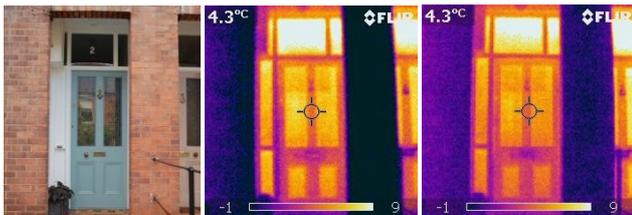
Fig. 11. Door and external thermal image of door with no intervention (centre) and door with curtain (right)

panels are more yellow than orange. Conversely, the brick wall to the side of the porch is darker as the image was taken later at night and the brick work was colder due to longer exposure to the cold night air. This further highlights the loss through the door with no curtain.

The curtain comprised of thin thermal lining with very low thermal mass. It appears to have little influence on air leakage and reducing heat transfer is likely on account of trapping an insulation layer of still air between the curtain and door.

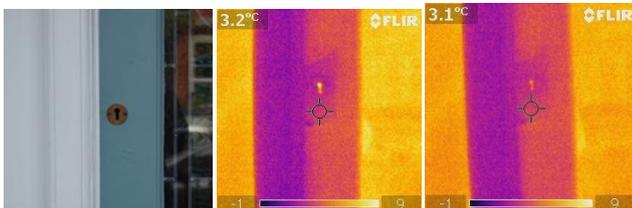
Fig. 12. Door and external thermal image of door with no intervention (centre) and door with curtain (right)

The effect of using a keyhole cover for draughts and room temperature variations was not measured due to the very small size of the aperture and likely negligible results. The thermal image however clearly shows reduced air leakage through the keyhole when using a keyhole cover (Fig 12 – right) compared to without (Fig. 12 –centre).

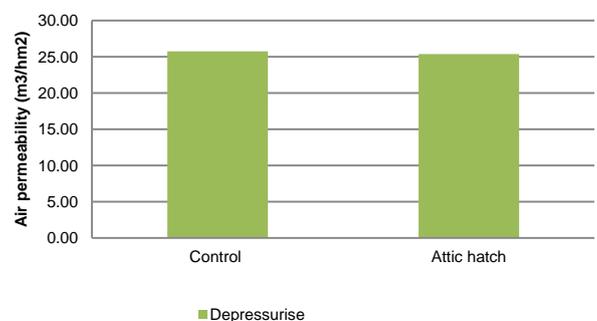
Fig. 15. Air permeability (m<sup>3</sup>/hrm<sup>2</sup>) of room 3 with and without the attic hatch cover and Fig 16. Internal and external temperature logging for room 3, with and without

the attic hatch cover.

The air permeability and room temperature results for room 3 are shown in figures 15 and 16 and table 6. Only depressurisation results are shown for the air permeability on account of an error occurring (sealed door opening) during pressurisation.

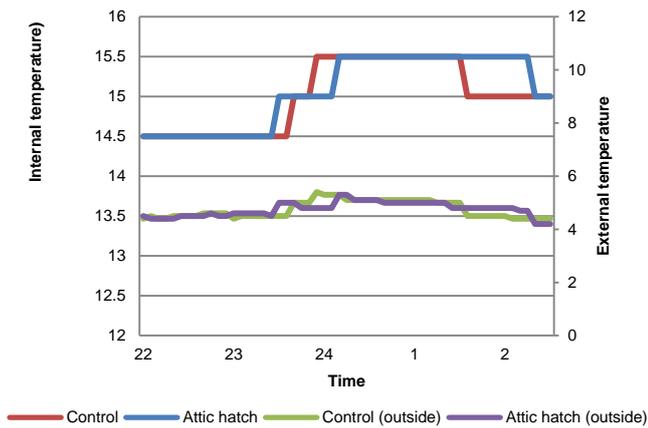
Fig. 16. Internal and external temperature logging for room 3, with and without the attic hatch cover.

Monitoring the temperature on the landing suggest that the attic hatch cover does not significantly impact the interior temperature. This may be partly due to the small size of the attic hatch cover (0.6 m<sup>2</sup>) when compared to the large volume of the hall, stairs and landing (approximately 77 m<sup>3</sup>). This is further confirmed by the air blower results and thermal imaging. The air blower tests showed a reduction in air flow rate of 62.6 m<sup>3</sup>/hr @50Pa (only 1.5% reduction). This figure is in keeping with Stephans (1998) who attributed only 2% air infiltration to the loft hatch [15]. The thermal image of the loft hatch without the cover (fig 16- centre) suggests some cold air infiltration around the seal from the attic above. Comparing the thermal images with and without the attic hatch cover (fig 17) suggests little difference in the temperature surrounding the hatch.

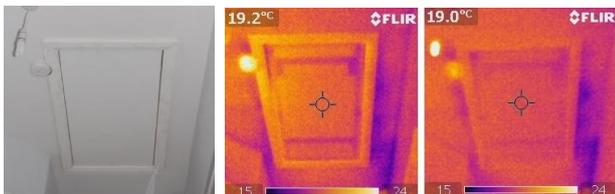
Fig. 17. Interior of attic hatch with thermal image without attic hatch cover (centre) and with attic hatch cover in roof above
