Mechanical And Structural Analysis Of Rock Slide In Ado Ekiti, Ekiti State Nigeria

¹Oluwaseyi A. O., ²Kutelu B. J. and ³Oso O. O.

^{1,2,3} Department of Mineral and Petroleum Resources Engineering Technology,
Federal Polytechnic, Ado-Ekiti, Nigeria.

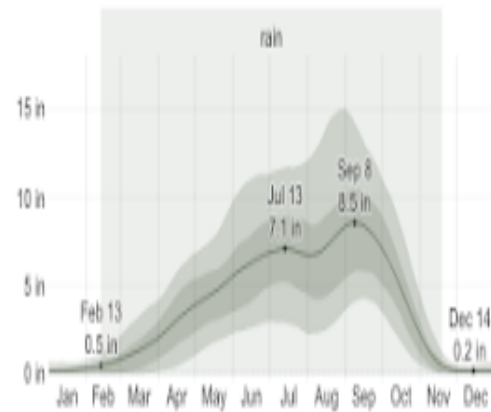
Fig. 2. Average monthly rainfall, Source: NASA's MERRA-2 satellite-era reanalysis

Ado-Ekiti experiences extreme seasonal variation in monthly rainfall. Averagely, the rainy period of the year lasts for 9.2 months, from February to November, with a sliding 31-day rainfall of at least 1.27 cm. The most rain falls around September, with an average accumulation of 21.59 cm. The rainless period of the year lasts for 2.8 months, from November to February. The least rain falls around December, with an average total accumulation of 0.51 cm.

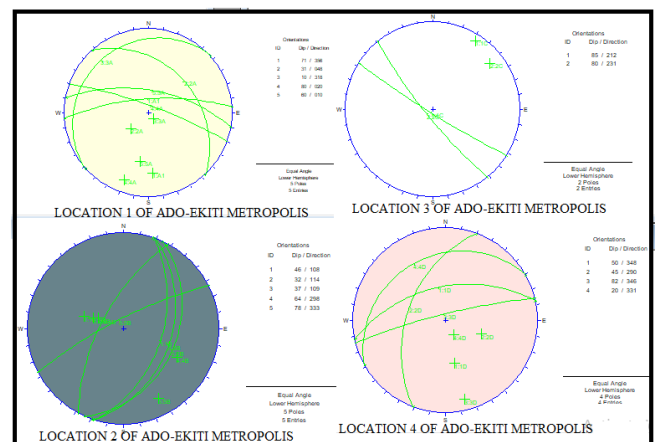
Fig. 3. Stereonet of discontinuity planes of Locations 1 to 4 of Ado-Ekiti Metropolis

Results obtained from the field and the laboratory is presented in Table 2 and Plates 1 to 4. The UCS results that range from 66.59 to 94.53 Mpa showed that the boulders are of very high strength. This implies that when collided with any object along its path during consequential sliding, its negative effect is possible to be high. Also, the structural conditions as shown in fig. 3 and Table 2, where discontinuities and bedding plane crossed each other, could be the reason why there appeared boulders of different sizes and weights in the locations studied.

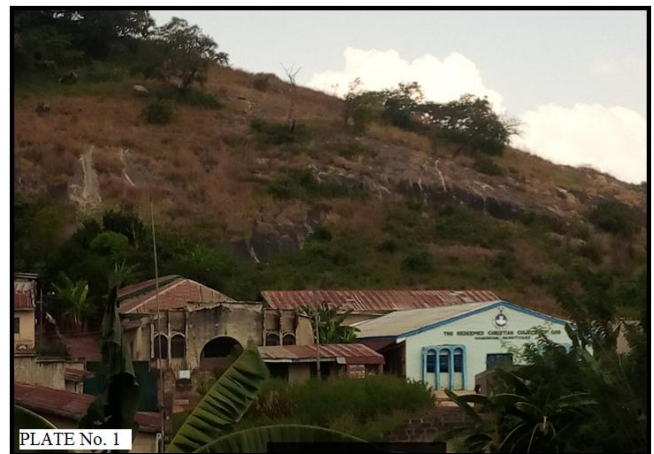
The rocky outcrop in the Location 1 reveals porphyritic granite lithology with several intrusion of quartzite, xenoliths of charnockite quartz vein and is highly weathered through long influence of rainfall which lead to gradual wear of the rock, the high tropical temperature of the day and the drastic cooling of the night that produces cracks which occurs due to contraction and expansion of the same, and later harbor the growth of trees whose roots causes the cracks to expand and later peel off parts of the formation. This later form the boulders that are found on the top of the mountain as it can be seen on Plate no. 1. The size of the block of rocks ranges from 0.57 to 23.9 tons. The slope angle of the upper section of the rock is about 35° with slope length of 36 m and the boulders were hanging on different point of the slope. However, the lower part has a slope angle of 82° and slope length of 9 m. Rock sliding, in this location, was initiated by climatic and biological conditions as trees and grasses were also found grown on the mountain. The events created by these conditions may include increase in pore pressure due to rainfall infiltration, erosion of surrounding material during heavy rain storms, chemical degradation or weathering of the rock, root growth or leverage by roots that caused part of the rock to break off (Day, 1997; Hoek,2000).

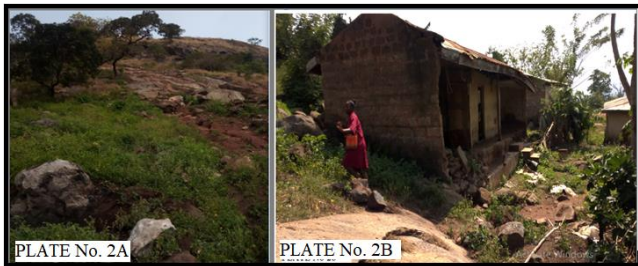
In location 2, the outcropped surface revealed extensive weathering activities with the creation holes within the rock mass ,the lithology shows migmatite with various intrusion, the various resistance of the different consistency intrusion created quartz vein, dissolution holes, charnockite, biotite granite and quartz veins. During heavy rainfall in the zone, the weathered rock mingled with soil turned to liquid soil which runs down the slope angle of about 71° and rock blocks of weights between 0.03 ton and 8.16 tons were partly rolled and partly slid down the slope. The path of the slid rock can be seen in Plate No. 2a and through a slope length of 55 m. Some of the hauled rock got stopped by the talus present on the slope path. This was due to the fact that the resisting force of the slope surface was greater than the driving force on the rock which made the rock to decreased in speed and consequently came to a stop on the slope segment; a mechanism in which the slope angle (θ) < friction (ϕ). The other boulders were stopped by the building at the base of the mountain thereby damaging it as a result of the rock impact (Plate No. 2B), but there was no life lost.

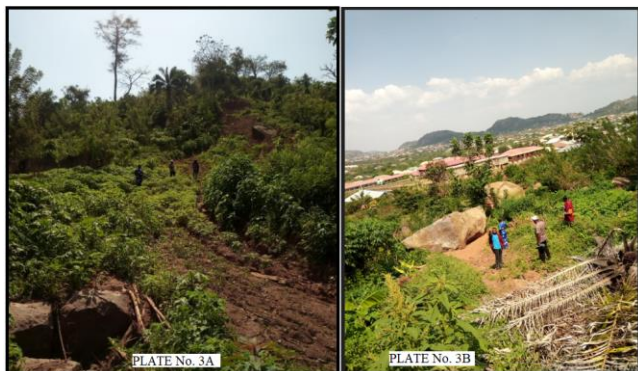
The lithology of location 3 (Plate No. 3 A) revealed granitic rock outcrop with considerable superficial deposit of residual soil made of lateritic clay with brownish red colour showing intensive effect of weathering activities. After long period of continuous heavy rainfall in Ado-Ekiti, Nigeria, the lateritic got dissolved and set in motion down slope, conveying two blocks of rocks of weights 15.26 tons and 37.93 tons, firstly, through a distance of 15 m along 65° slope angle and then through a path of 56 m long on a slope angle of 45° . The movement was consequently stalled by the shrubs and trees on their path (Plate 3 B). The devastating effect of the rock slide would have been enormous if the plot where the incident happened had been developed into habitation. The climatic condition that initiated the boulder's movement was the accumulated heavy rainfall that liquefied the weathered lateritic rock.

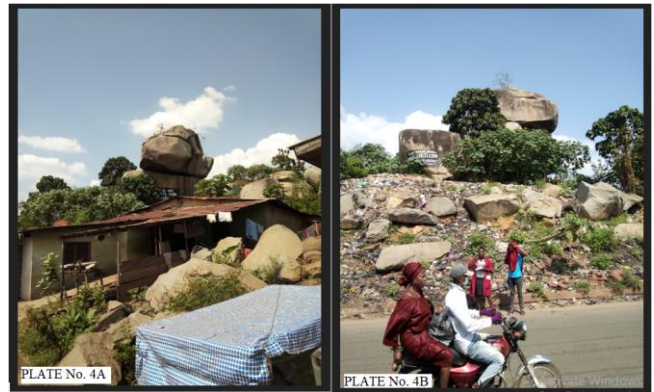
Finally, Plate 4 A and B were outcrops that revealed granitic lithology with intense disintegration of the rock mass, reflecting a high degree of physical weathering activity in the terrain, in addition to many boulders of the formation. The hanging rocks are about 25.35 ton (plate No 4 A) and 28.44 ton (plate No. 4 B) which have been there for quite a long time. Road and building for habitation were constructed near the rock site. They were supported underneath by a small contact of rock. The stability observed in this position is due to the principle of centre of gravity which hold it in place, or else, it would have fallen off and cause great havoc to the dweller or possibly motorist. Notwithstanding, further weathering of the rocks or any consequent occurrence of blast that produces seismic wave may likely cause rock fall.

According to the observation noted in this research work, it is recommended that the resident presently living in the houses built at the foot of the mountains should be relocated and their residential permit in those locations be revoked.
