Engineering Analysis Of Slope Failure Of A Kaolin Quarry At Kurra, Jos North-Central Nigeria

Abstract— Geotechnical analysis of a kaolin quarry in kurra was carried out to determine the safety factor of the slope and its susceptibility to failure. Five different lithologies were identified and their geotechnical properties such as unit weight, water content, Atterberg's consistency limit, particle size distribution, specific gravity and shear strength parameters were determined. Also x-ray diffraction analysis was carried out and the factor of safety was calculated using the Morgenstern-Price method. Results obtained show that the liquid limit values range from 32% to 39%, the indices of plasticity values range from 15% to 25%. Bulk density values range from 1.40g/cm³ to 1.49g/cm³. Cohesion values range from 60KPa to 70KPa and the angle of internal friction value ranges from 23° to 30°. The samples contain a high percentage of fines ranging from 45% to 82% with sand ranging from 14% to 50% and gravel ranging from 3% to 7%. XRD analysis show that kaolin, smectite, talc, ilmenite, montmorillonite and gibbsite amongst others are present in the samples. A factor of safety was calculat

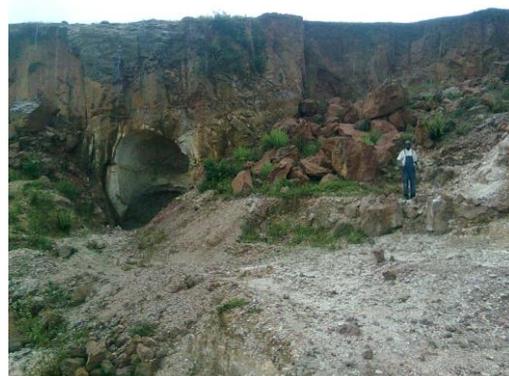
The studied area (Fig. 3) comprises of a geological sequence with five distinct layers. The first layer comprises of laterite underlain by lateritized older basalt, reddish kaolin, pure white kaolin and a weathered migmatite layer. Field study of the Kurra kaolin reveals the emplacement of basaltic lava into the pre-existing migmatitic gneiss of the area. The eruption of the basaltic magma which occurred between tertiary to recent times probably transformed the pre-existing migmatite to form the massive kaolin deposit of the area. The annual rising and lower of the ground water table in the area over geologic time coupled with climatic conditions created a geochemical pathway for the lateritization process. Laterites are recognized as alteration product in the crystalline basement and on granites and basalts of Jos plateau.

Figure 3: The project site-showing a cave on the quarry face.

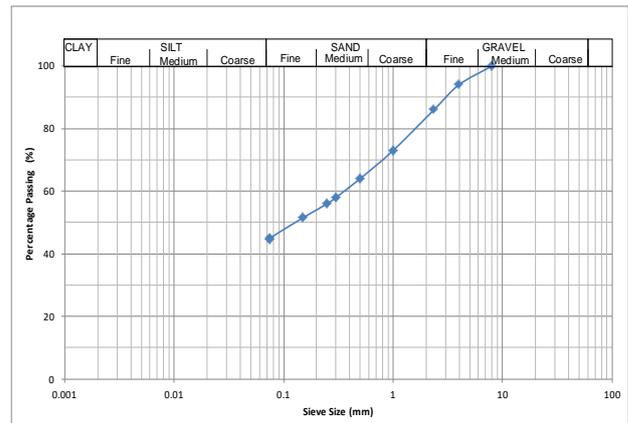
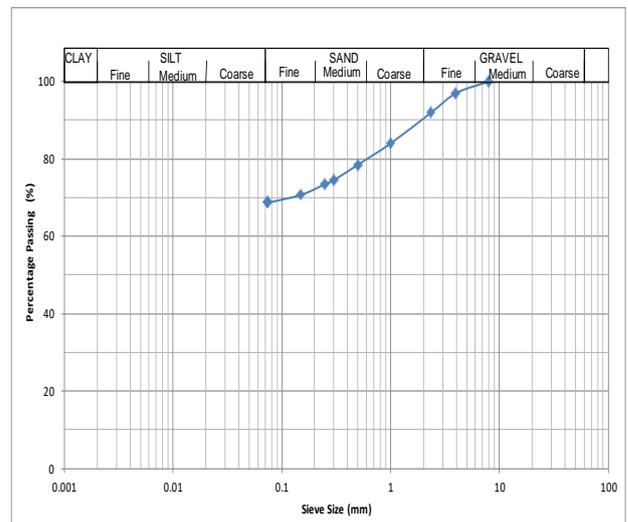
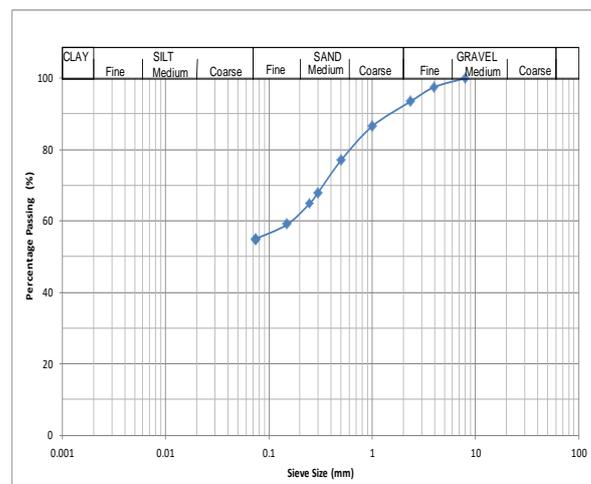
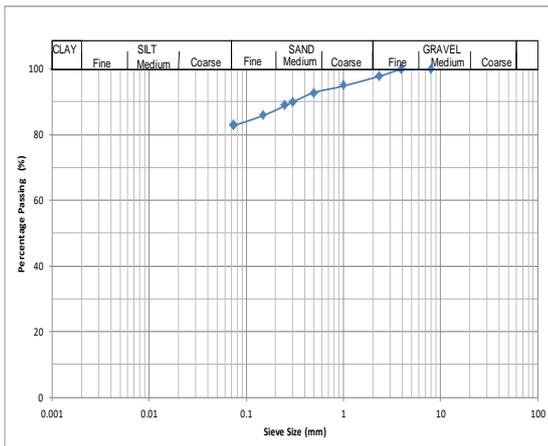
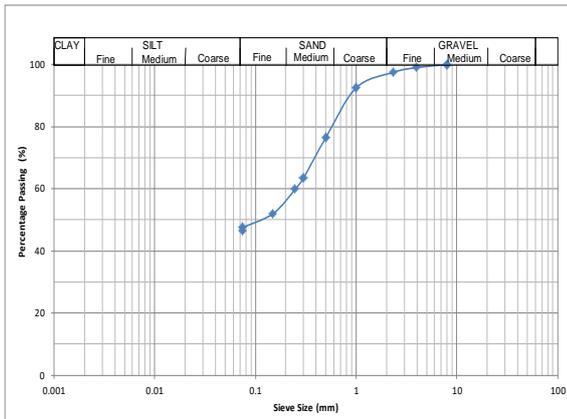
Conventional coarse sieve and fine sieve methods were used for particle size determination (Figs. 4a-4e). This revealed that the soils contain a wide variety of particle sizes and are well graded. Sample 1 contains 17% Gravel which is the highest in the sequence, 38% Sand and 45% Fines. Sample 2 consist of 9% Gravel, 22% Sand and 69%Fines. Sample 3 comprises of 6% Gravel, 40% Sand and 54% Fines. Sample 4 is rich in silt and clay materials having the highest percentage of 82 in the sequence. It also consists of 4% Gravel and 14% Sand. Sample 5 consists of 3% Gravel, 50%Sand and 57% Fines. The sliding surface comprises less of gravel which stabilizes the soil and more of silt and

clay materials which are prone to movement. High content of fines results in poor stability of the soil [7].

Figure 4a: Grain size analysis graphs for Sample 1

Figure 4b: Grain size analysis graphs for Sample 2

Figure 4c: Grain size analysis graphs for Sample 3

Figure 4d: Grain size analysis graphs for Sample 4

Figure 4e: Grain size analysis graphs for Sample 5

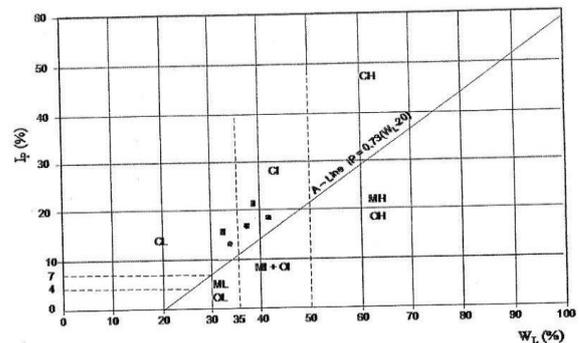
The soils are of medium plasticity, having plasticity indices ranging from 15 to 20 [3]. On the plasticity chart, the soil falls above the “A” line in the CL group. This group consists of inorganic clays of low to medium plasticity which are practically impervious with fair shearing strength and compressibility when compacted and saturated [8].

Figure 5: Soil classification chart for the samples

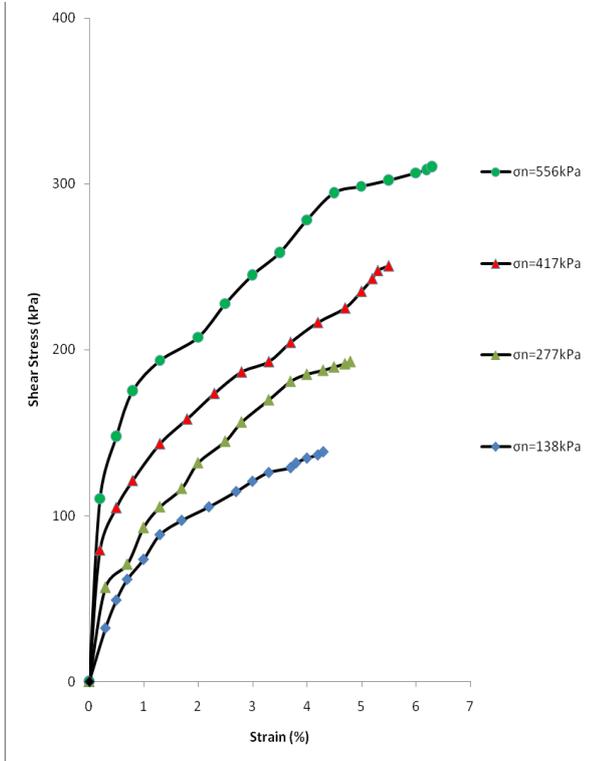
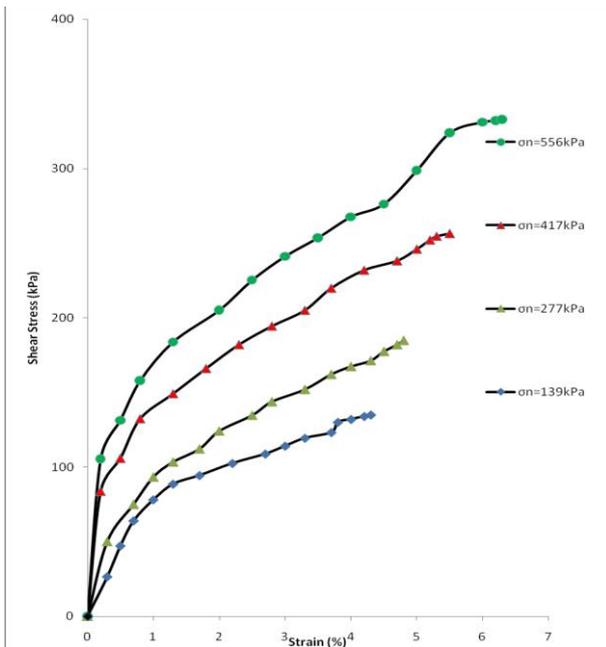
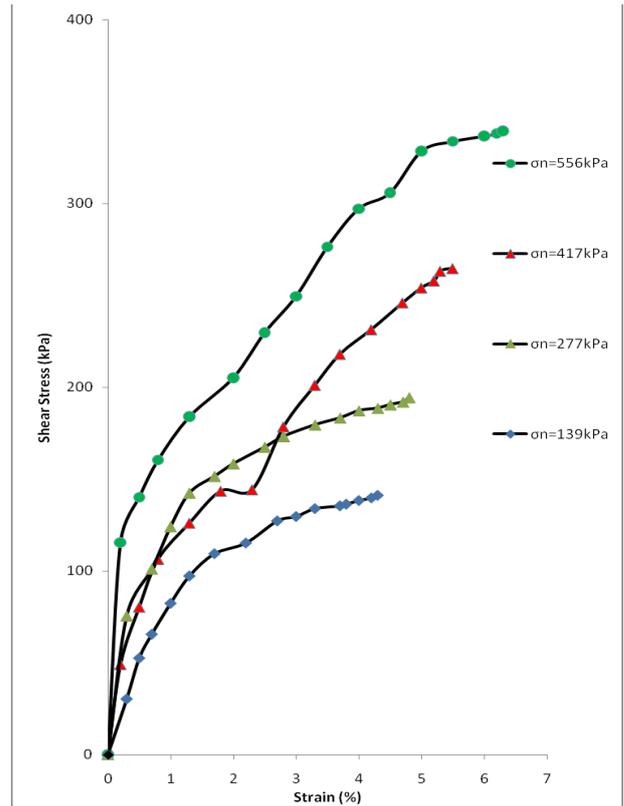
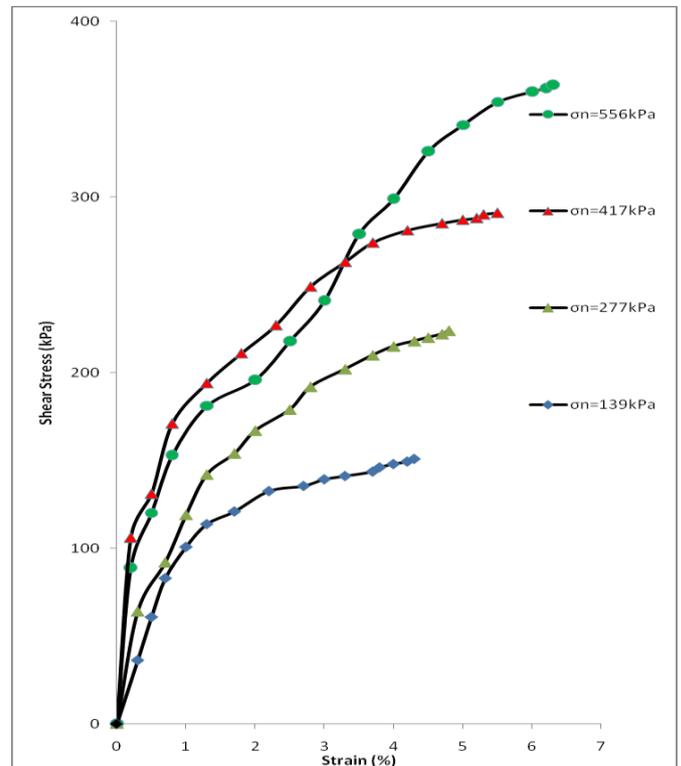
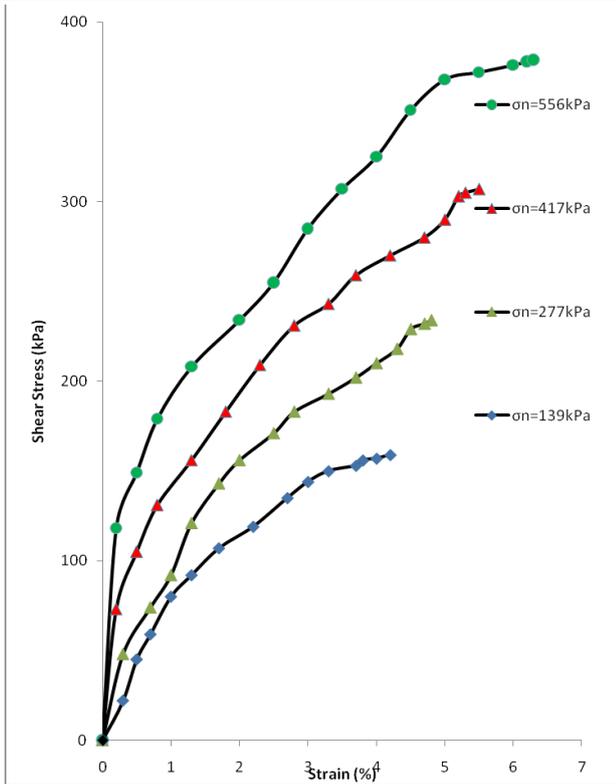
The shear box test (Figs. 6a-6e) reveals that the soils are of high strength having cohesion values ranging from 60KPa to 70KPa with an average of 65KPa. Also the angle of internal friction (Figs. 7a-7e) ranges from 23° to 30° with a mean of 26° . These values indicate that the soil have high bearing capacity as a result of its high cohesion and angle of internal friction values.

Figure 6a: Graph of shear stress vs. shear strain for the sample 1.

Figure 6b: Graph of shear stress vs. shear strain for the sample 2.

Figure 6c: Graph of shear stress vs. shear strain for the sample 3.

Figure 6d: Graph of shear stress vs. shear strain for the sample 4.

Figure 6e: Graph of shear stress vs. shear strain for the sample 5.

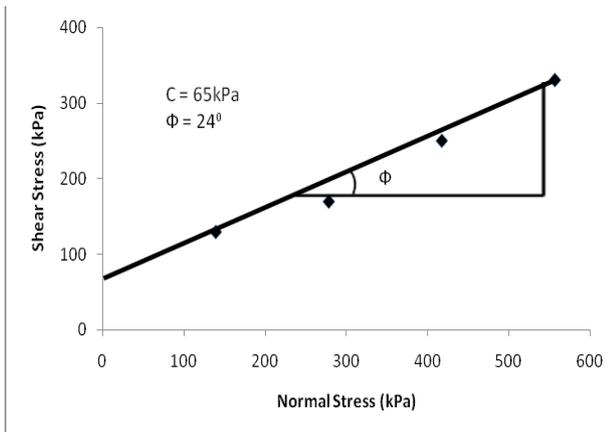
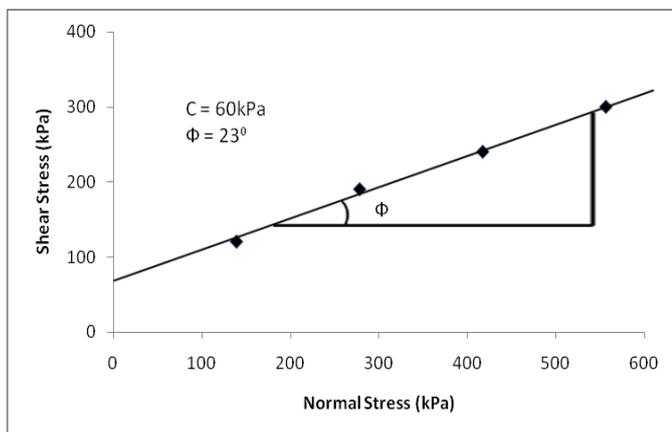
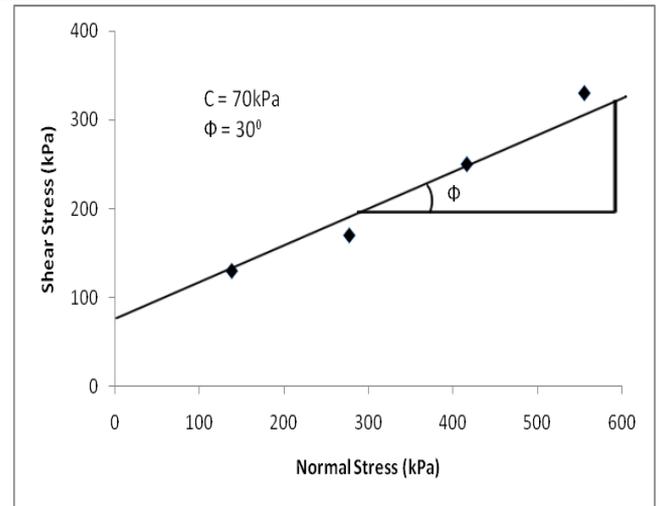
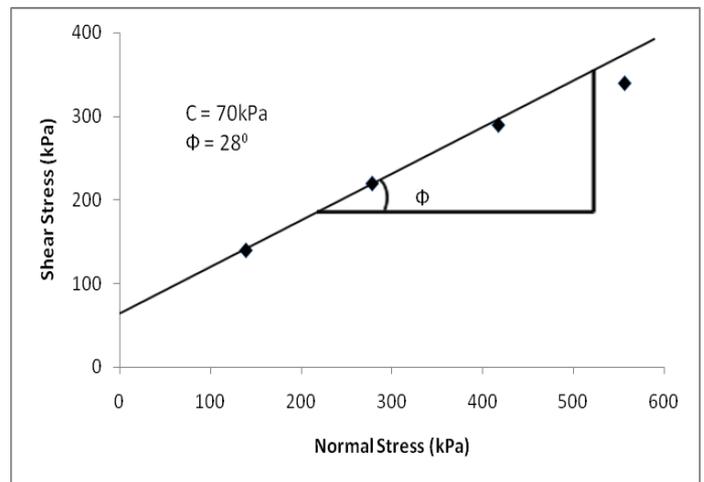
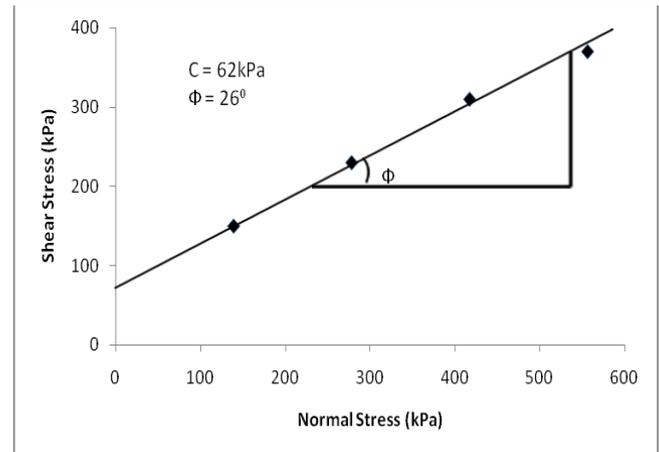
Figure 7a: Graph of shear stress vs. normal stress for the sample 1

Figure 7b: Graph of shear stress vs. normal stress for the sample 2

Figure 7c: Graph of shear stress vs. normal stress for the sample 3

Figure 7d: Graph of shear stress vs. normal stress for the sample 4

Figure 7e: Graph of shear stress vs. normal stress for the sample 5

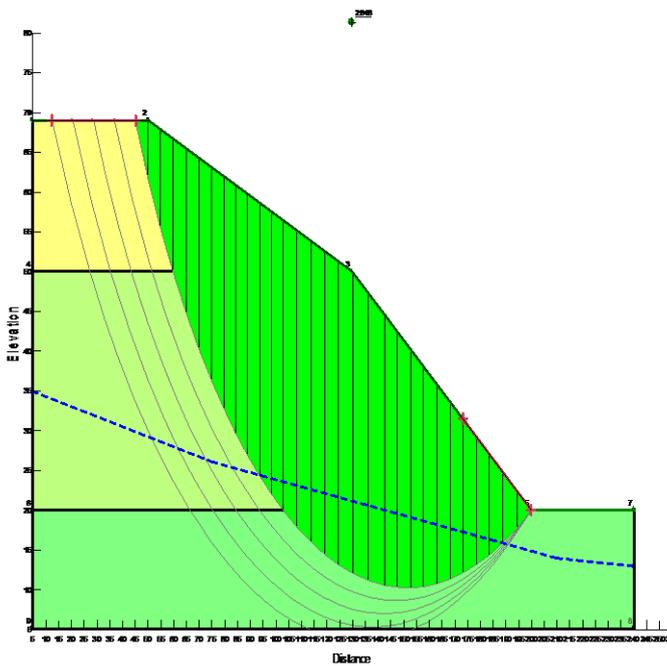
Results obtained from engineering tests carried out were used to determine the stability of the slope by employing the Morgenstern-Price method of slices. Based on field observation at the slide area, the mode of failure has been categorized as a rotational slide. A number of slide circles (Fig. 8) were investigated in order to find the lowest critical slip surface which is the surface that gives the lowest factor of safety value. The lowest value yielded is given as 2.85 while the highest value is 4.45. Fig. 9 displays the region that is more stable for mining to be carried out.

Figure 8: Critical Slip with Alternate slip surfaces

Slope failure is mainly as a result of high precipitation which usually occurs in rainy season [16] and materials analyzed from the sliding surface were collected during the rainy season. Since the lowest value is 2.85 hence, it implies that the slope is stable and failure is not immediate.

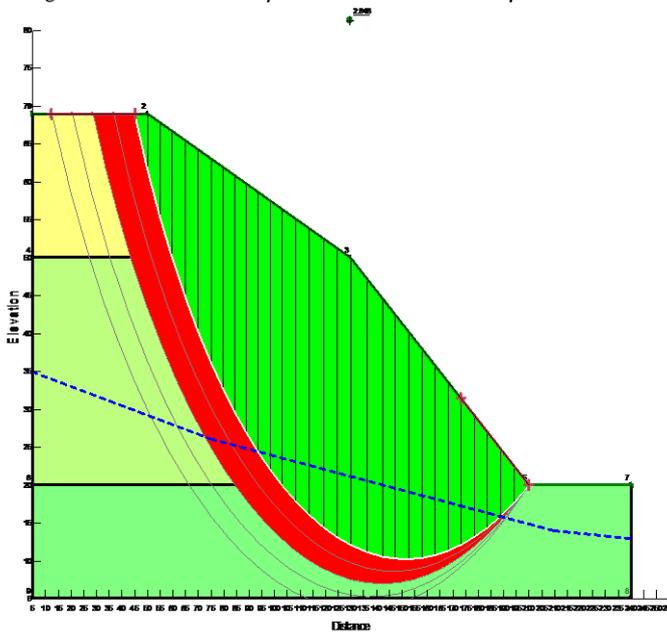
Figure 9: Safety Map showing area safe for mining operation in red.

slope is stable for the time being. To reduce the rate of failure, ground water has to be reduced. This can be done by constructing subsurface drainage in the area. Also, modern techniques can be employed in mining the kaolin within a safe angle to prevent collapse of the structure.

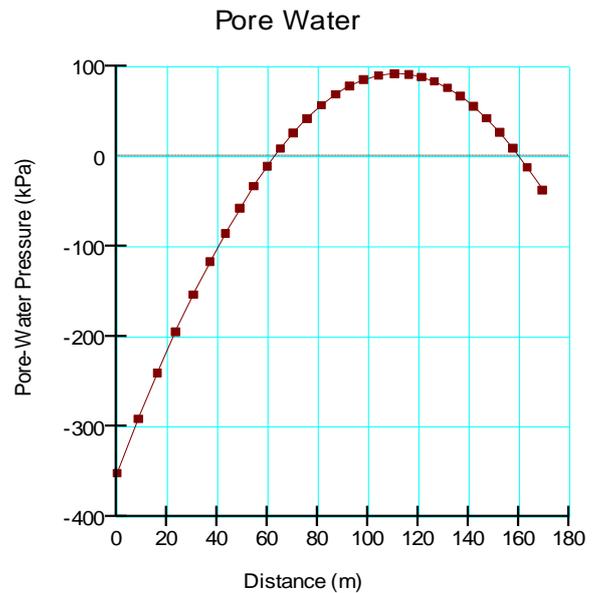
Rainfall and a rise in piezometric surface drive an increase in pore-water pressure. The variation in pore-water pressure along the slip surface (Fig. 10) was determined from the piezometric level showing a change from negative to positive pore pressure. Under negative pore-water pressure conditions, the shear strength does not change at the same rate as for positive pore-water pressure [15]. The inter-slice normal and shear forces (Figs. 11a and 11b respectively) vary across the slip surface as a result of the difference in the mass of each slice, the piezometric water level and percolating water.

Figure 10: Pore-Water Pressure across the Critical Slip Surface

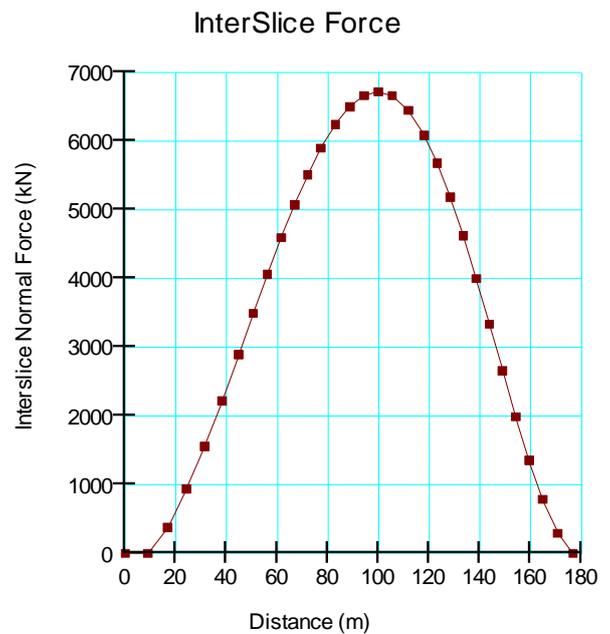
Figure 11a: Inter-slice Normal Force across critical Slip Surface

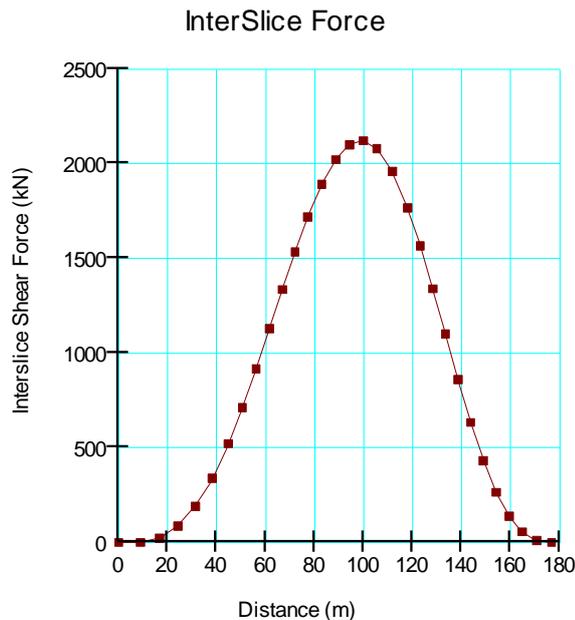
Figure 11b: Inter-slice Shear Force across critical Slip Surface.
